**Norwood Young America Parks and Recreation Commission
Tuesday, September 15, 2015 at 5:30 p.m.
Oak Grove City Center ~ City Council Chambers, 310 Elm St. W.**

Re: **Old Town in the Park – Exterior Assessment**
21 Main Street East
Norwood Young America, MN 55368

At your request, Encompass has performed an exterior assessment of the Old Town in the Park building located at 21 Main Street East in Norwood Young America. The purpose of this review was to assess the condition of the exterior envelope and provide recommendations for repair to address specific concerns relative to moisture intrusion and premature deterioration.

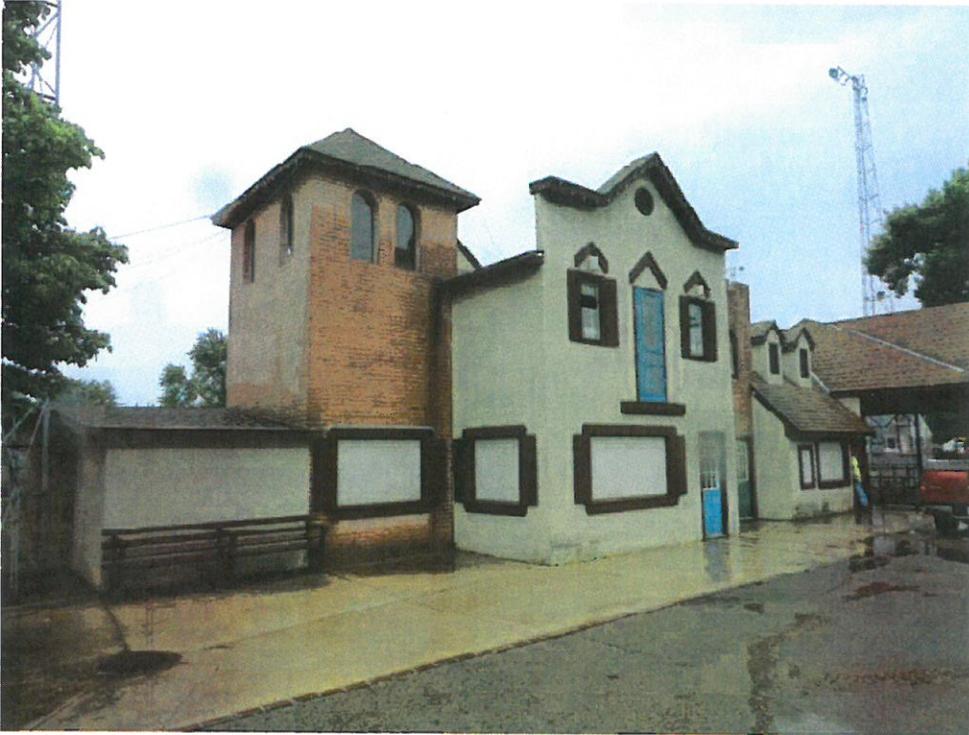
- 1.1. Old Town in the Park is a two-story, wood-framed structure constructed in 1991. The structure is used for concessions, storage, and baseball clubhouse facilities (Photo #1). The exterior is clad entirely with stucco that is stamped, colored, and textured to achieve various aesthetics. The interior is primarily unfinished, though some areas have wood paneling. The structure is unheated and winterized for winter months.
- 1.2. It is our understanding that the structure has experienced moisture intrusion, particularly along the wall base of the north and south walls, as well as around window openings at concession areas. The focus of this review is to assess the likely extent of moisture intrusion and provide recommendations for repair along with associated opinion of probable cost estimates.

Photograph #1 – North Elevation

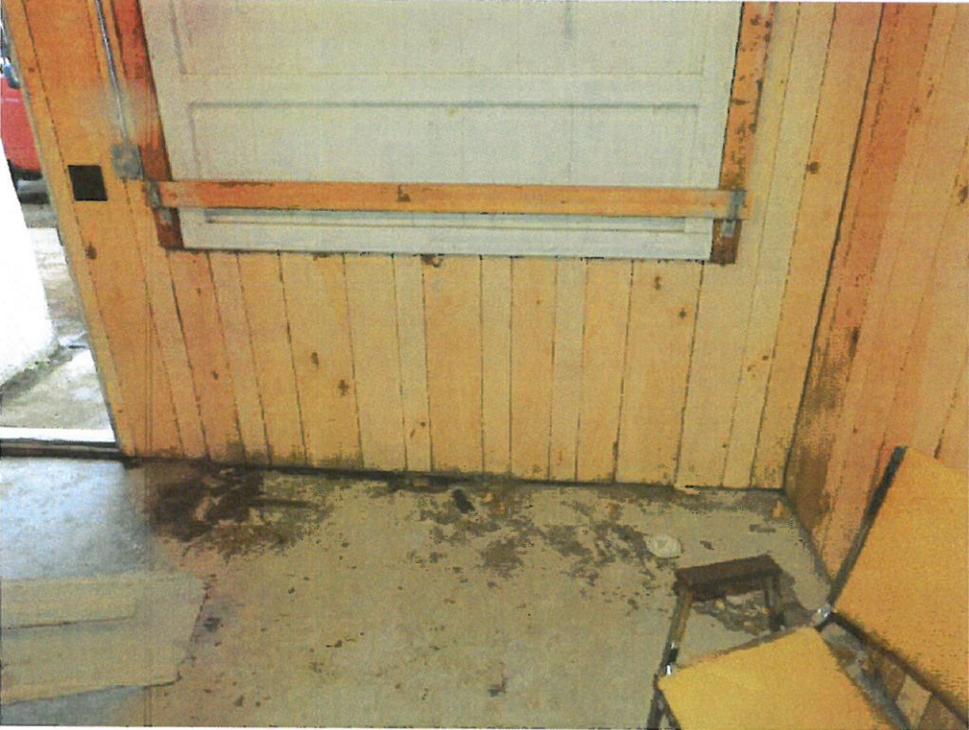
- 2.1.2. Water was observed leaking under the wall plate and into the building at the time of our site visit (Photo #2). Various other similar water stains were observed along the perimeter of the north and south walls.

- 2.1.3. The as-built configuration with the wood framing installed at the same height as exterior grade allows exterior moisture to drain under the framing and to the interior. This condition is exacerbated by poorly sloped exterior grading and the absence of waterproofing. This configuration exists primarily along the north wall, and to a lesser extent at the east and west walls which are exposed to significantly less moisture.

Photograph #2 – Moisture on floor of North Wall

- 2.1.4.1. Sawcut and remove stucco along base of wall, shore and remove lower 8" of wood framing (plate, studs, and sheathing) and install one course of CMU around perimeter of building atop the existing foundation wall. Install new sheathing and finishes. It should be noted that the interior concrete floor is poured against 2x4 wall plate and will need to be sawcut back to allow for a 6" or 8" CMU that can then be structurally anchored to the top of the existing foundation wall.
- 2.1.4.2. Remove all concrete sidewalk adjacent to the north wall and install new concrete that is sloped towards the nearby catch basin and away from building walls.
- 2.1.4.3. At the south elevation, excavate gravel and install drain tile and drain rock that is directed to the catch basin to the west of the site.
- 2.1.4.4. Consider installing gutters and downspouts to all roof eaves.

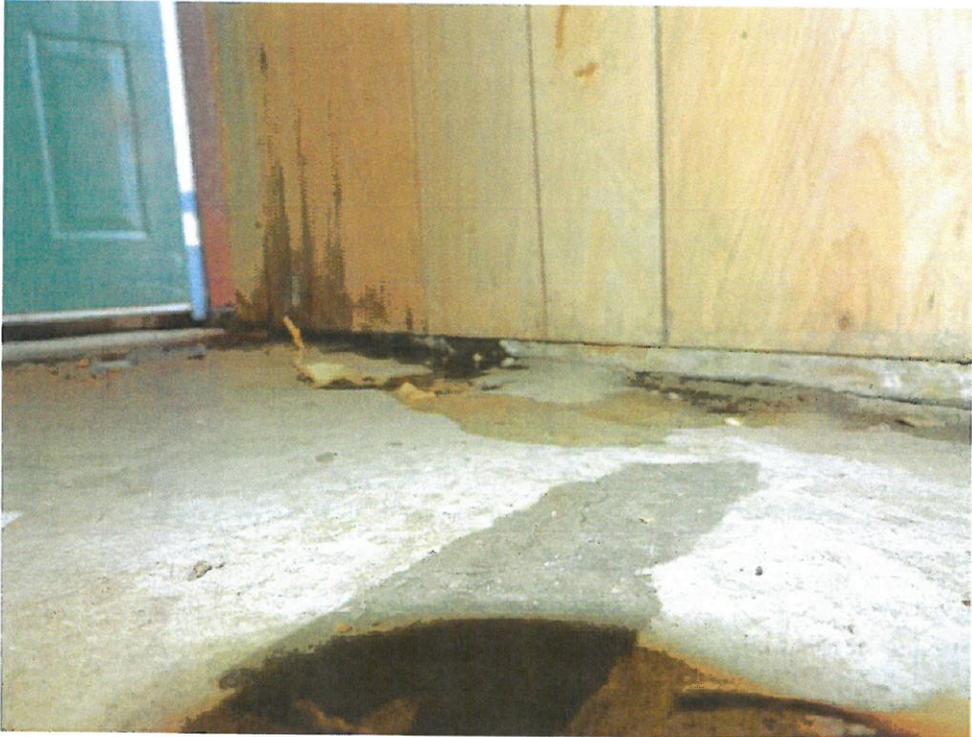
- 2.1.1. The exterior walls consist of 2x4 studs framed atop a masonry foundation. The bottom of the framing is set at the same height as the exterior surrounding grade and the interior concrete floor (photo #3). No waterproofing is installed along the base of the wall. The exterior grade is relatively flat and in areas slopes towards the building.

Photograph #3 – Typical Wall Base

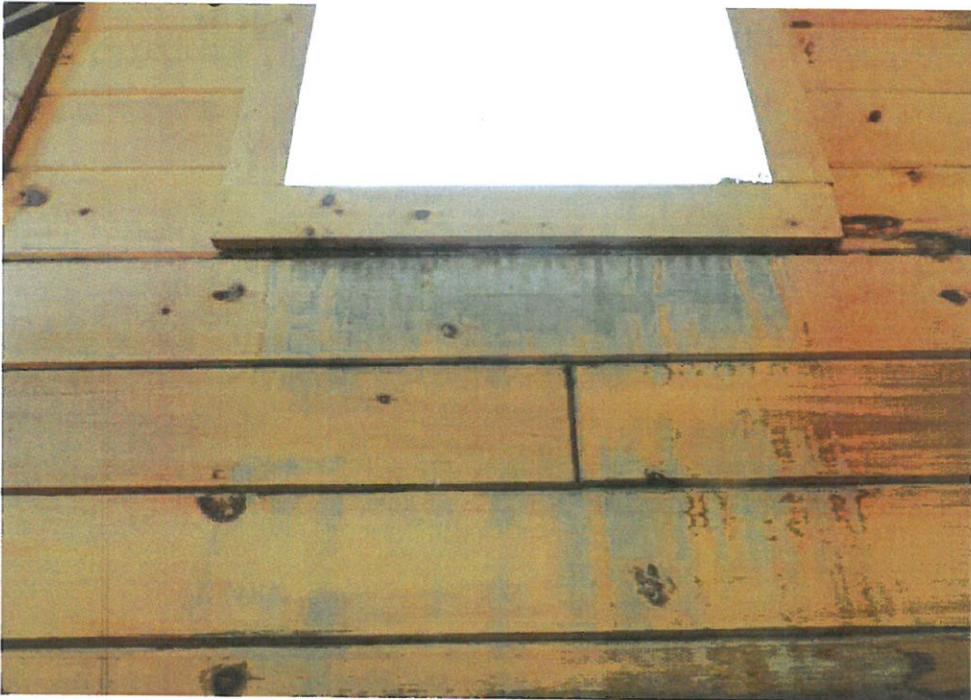
- 2.2.1. The exterior walls are entirely clad with stucco that is colored and textured to various patterns. Moisture staining/deterioration was noted on the interior side of sheathing/paneling in multiple rooms on both the upper and lower levels (photos #4-6). The staining was most severe below window and roof/wall intersections.

2.2.2. Most window and concession openings are hand framed with either single-pane Plexiglas or wood shutters. No flashing is present around or below the openings and deteriorated wood trim and framing is present at many of the openings. The openings have no means for collecting and/or preventing moisture from entering behind the stucco installed below. The window and concessions frames are not water tight and have limited ability to prevent moisture intrusion. Moisture that enters through these openings is directed behind the stucco with no means for drainage.

Photograph #4 – Staining below window at north wall

2.2.4.1. In reviewing the as-built installation and the varying textures, colors, and aesthetics, it is our opinion that all of the stucco should be removed from all walls. This is the only way to correct underlying damage below windows, openings, and roof intersections while providing a continuous weather barrier that can accommodate and direct incidental moisture out of the wall assembly. It is our opinion that partial removal of stucco cannot correct all underlying issues.

2.2.4.2. Upon removal of stucco, deteriorated sheathing should be removed and replaced. It is recommended that all windows, concessions, and doors be removed and replaced. This will allow for installation of flashings necessary for the overall weather barrier. Concessions should have solid surface/material counter tops instead of wood to limit the potential for leaks.

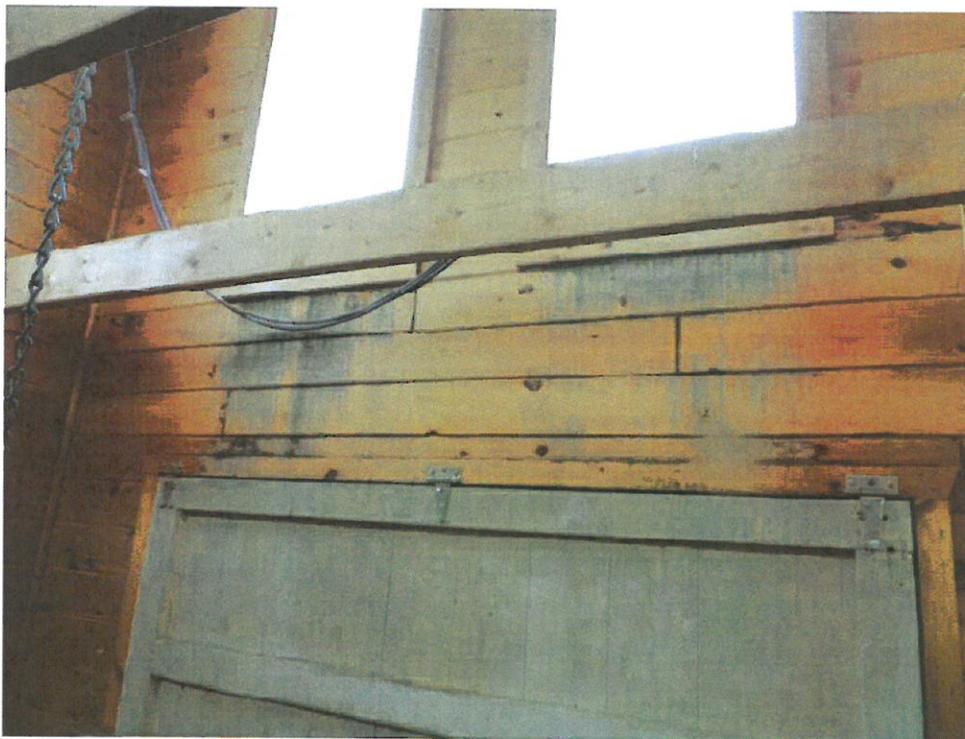
Photograph #5 – Staining below windows at south wall

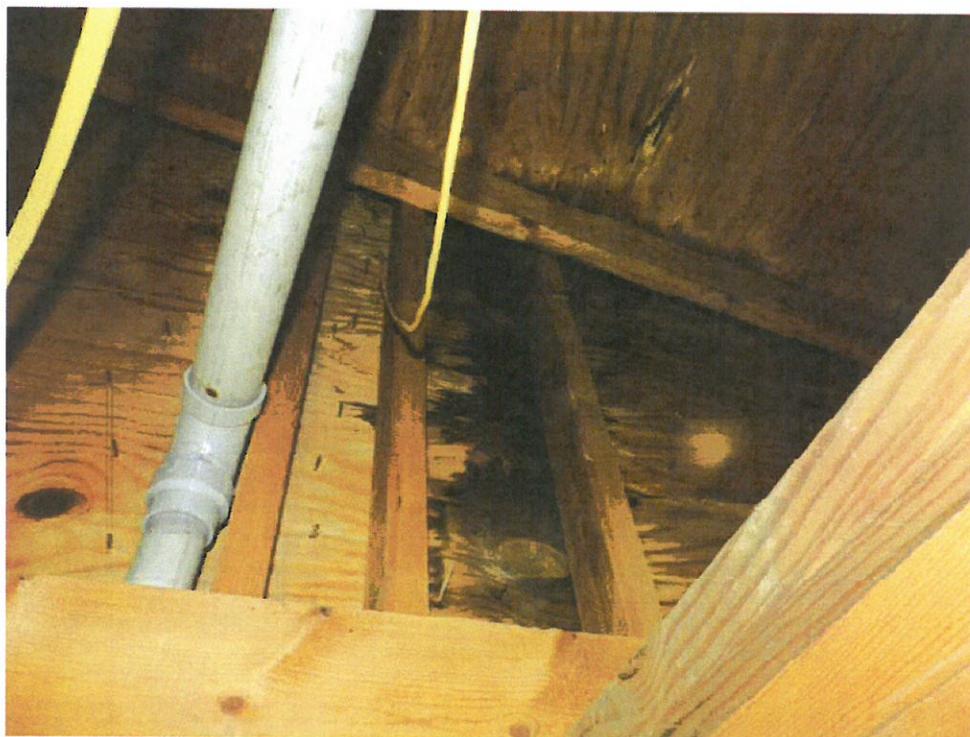
2.2.3. Roof/wall intersections where a sloped roof terminates against a vertical wall are present on most elevations. These areas do not have adequate step or diverter flashing to direct water away from the wall or prevent it from entering behind the stucco. Damaged framing was commonly observed below most of these locations (photo #6).

Photograph #6 – Staining below roof/wall intersection

2.2.4.3. Roofing will need to be partially removed to install step flashings and diverter flashings along wall intersections. The full extent of roofing removal may vary depending on underlying damage and flashing needs, though it is expected that roofing removal may be significant where full roofing replacement may be more economical.

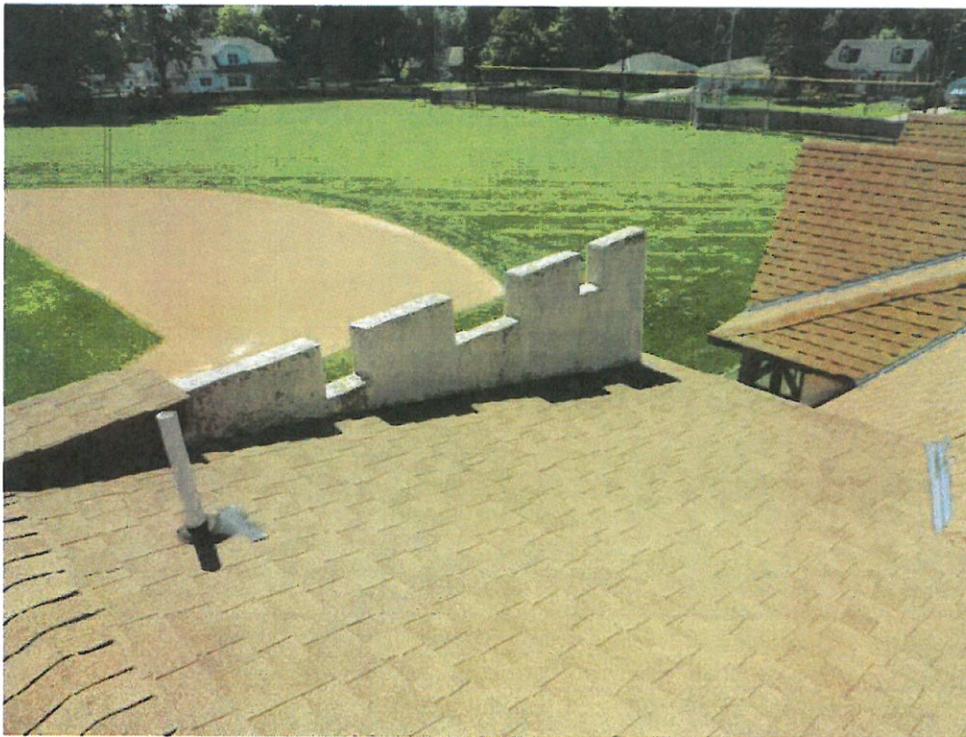
2.3.1. The parapet walls have flat top surfaces that are covered with wood and stucco. We suspect that underlying damage may exist below the caps that would not be known until the time of stucco removal (Photo #7). The use of stucco on flat surfaces is a poor construction practice and in order to ensure a water tight

Photograph #7 – Stucco parapet walls

assembly, it is recommended that the stucco and wood be omitted in favor of a roofing membrane and metal caps/coping.
