Norwood Young America Parks and Recreation Commission
Tuesday, January 16, 2018 at 5:30 p.m.
Oak Grove City Center ~ City Council Chambers, 310 Elm St. W.

SUBJECT: Willkommen Memorial Park – Old Town Buildings

Re: **Old Town in the Park – Exterior Assessment**
21 Main Street East
Norwood Young America, MN 55368

Home Inspection Report

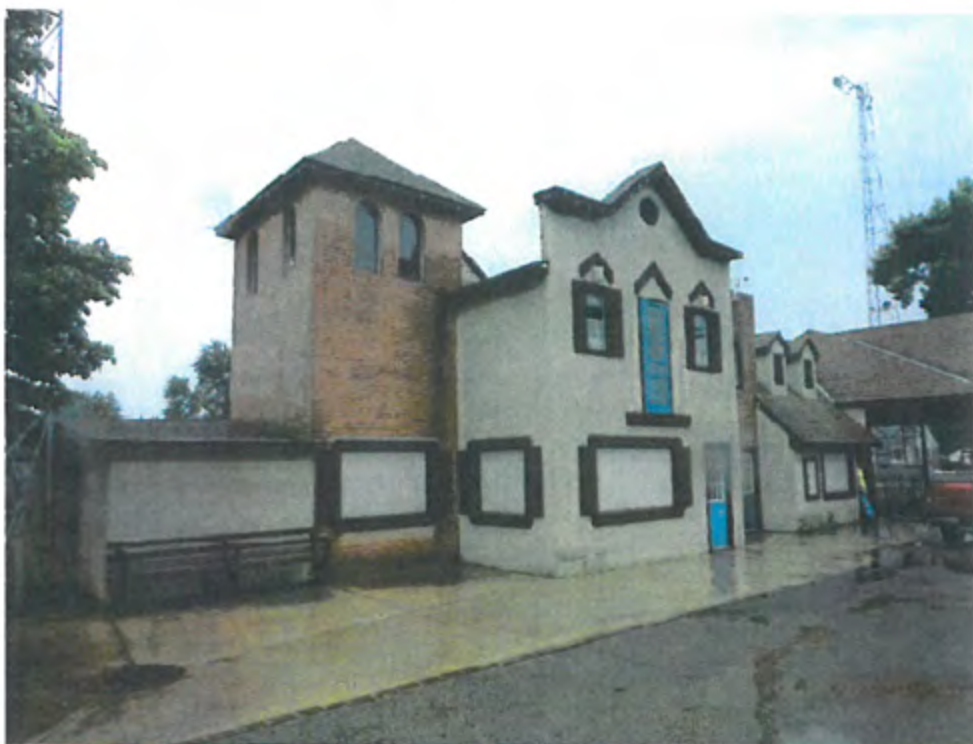
Photograph #1 – North Elevation

- 1.1. Old Town in the Park is a two-story, wood-framed structure constructed in 1991. The structure is used for concessions, storage, and baseball clubhouse facilities (Photo #1). The exterior is clad entirely with stucco that is stamped, colored, and textured to achieve various aesthetics. The interior is primarily unfinished, though some areas have wood paneling. The structure is unheated and winterized for winter months.
- 1.2. It is our understanding that the structure has experienced moisture intrusion, particularly along the wall base of the north and south walls, as well as around window openings at concession areas. The focus of this review is to assess the likely extent of moisture intrusion and provide recommendations for repair along with associated opinion of probable cost estimates.

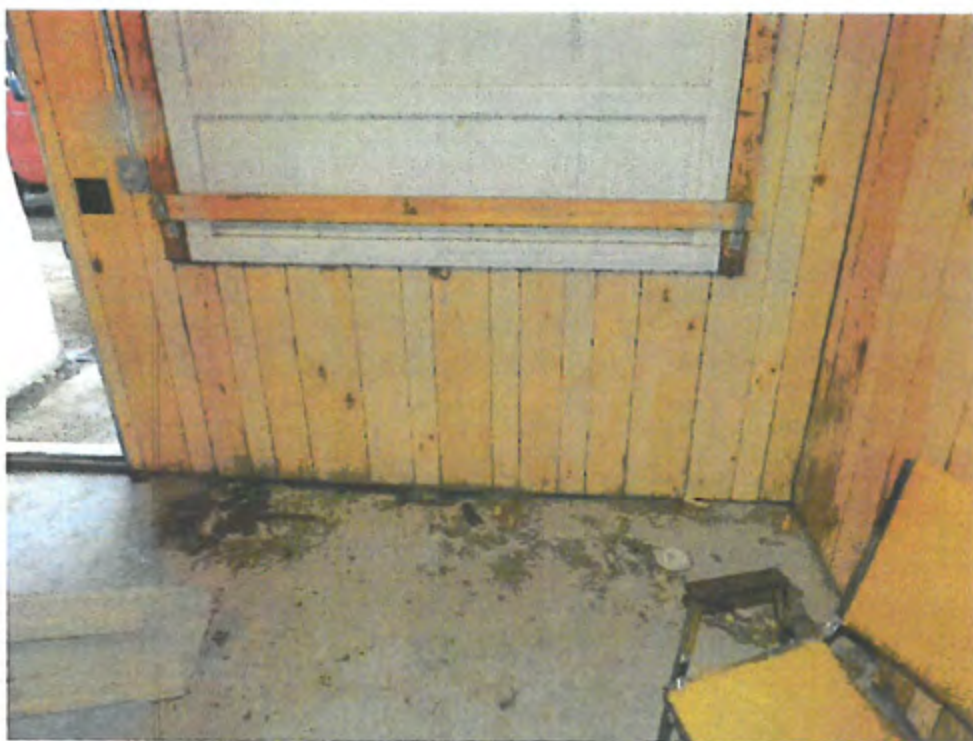
- 2.1.2. Water was observed leaking under the wall plate and into the building at the time of our site visit (Photo #2). Various other similar water stains were observed along the perimeter of the north and south walls.

- 2.1.3. The as-built configuration with the wood framing installed at the same height as exterior grade allows exterior moisture to drain under the framing and to the interior. This condition is exacerbated by poorly sloped exterior grading and the absence of waterproofing. This configuration exists primarily along the north wall, and to a lesser extent at the east and west walls which are exposed to significantly less moisture.

Photograph #2 – Moisture on floor of North Wall

- 2.1.4.1. Sawcut and remove stucco along base of wall, shore and remove lower 8" of wood framing (plate, studs, and sheathing) and install one course of CMU around perimeter of building atop the existing foundation wall. Install new sheathing and finishes. It should be noted that the interior concrete floor is poured against 2x4 wall plate and will need to be sawcut back to allow for a 6" or 8" CMU that can then be structurally anchored to the top of the existing foundation wall.
- 2.1.4.2. Remove all concrete sidewalk adjacent to the north wall and install new concrete that is sloped towards the nearby catch basin and away from building walls.
- 2.1.4.3. At the south elevation, excavate gravel and install drain tile and drain rock that is directed to the catch basin to the west of the site.
- 2.1.4.4. Consider installing gutters and downspouts to all roof eaves.

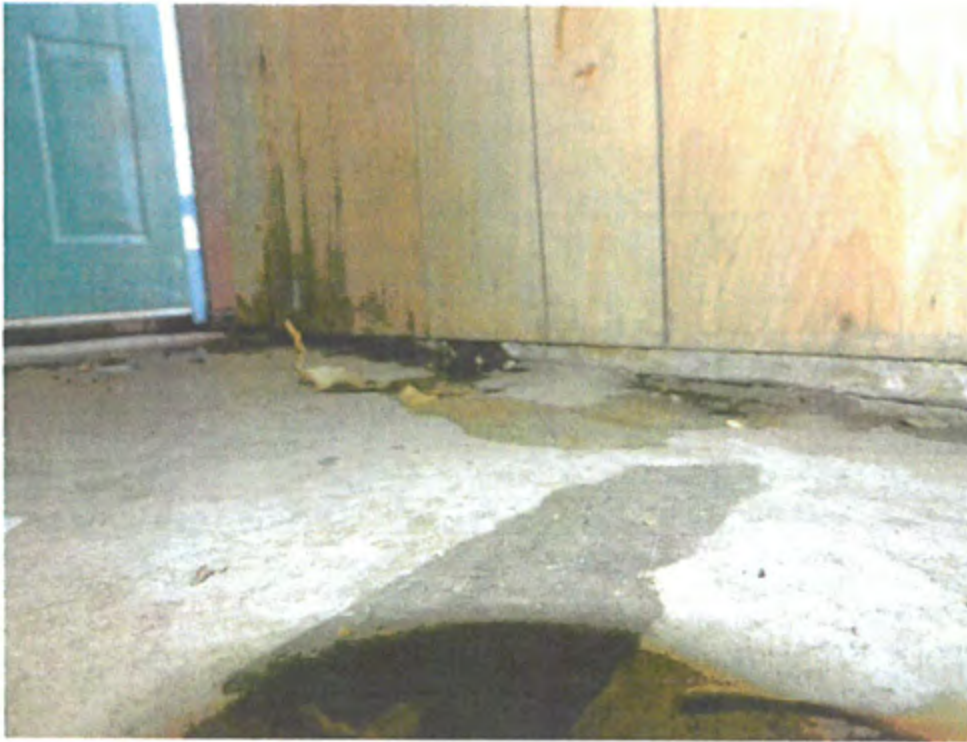
- 2.1.1. The exterior walls consist of 2x4 studs framed atop a masonry foundation. The bottom of the framing is set at the same height as the exterior surrounding grade and the interior concrete floor (photo #3). No waterproofing is installed along the base of the wall. The exterior grade is relatively flat and in areas slopes towards the building.

Photograph #3 – Typical Wall Base

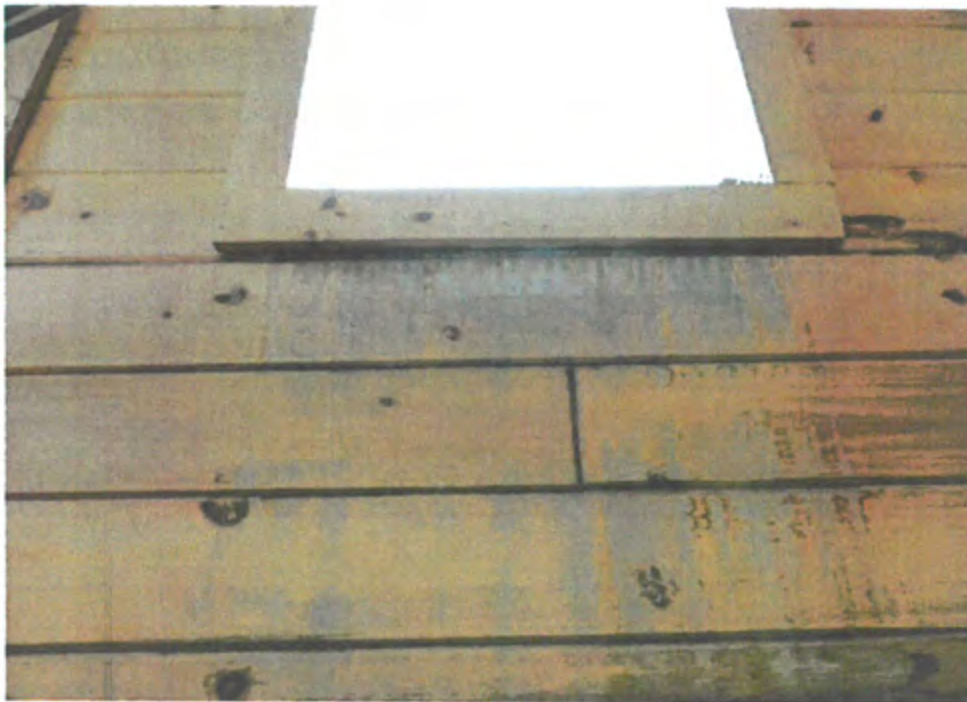
- 2.2.1. The exterior walls are entirely clad with stucco that is colored and textured to various patterns. Moisture staining/deterioration was noted on the interior side of sheathing/paneling in multiple rooms on both the upper and lower levels (photos #4-6). The staining was most severe below window and roof/wall intersections.

2.2.2. Most window and concession openings are hand framed with either single-pane Plexiglas or wood shutters. No flashing is present around or below the openings and deteriorated wood trim and framing is present at many of the openings. The openings have no means for collecting and/or preventing moisture from entering behind the stucco installed below. The window and concessions frames are not water tight and have limited ability to prevent moisture intrusion. Moisture that enters through these openings is directed behind the stucco with no means for drainage.

Photograph #4 – Staining below window at north wall

2.2.4.1. In reviewing the as-built installation and the varying textures, colors, and aesthetics, it is our opinion that all of the stucco should be removed from all walls. This is the only way to correct underlying damage below windows, openings, and roof intersections while providing a continuous weather barrier that can accommodate and direct incidental moisture out of the wall assembly. It is our opinion that partial removal of stucco cannot correct all underlying issues.

2.2.4.2. Upon removal of stucco, deteriorated sheathing should be removed and replaced. It is recommended that all windows, concessions, and doors be removed and replaced. This will allow for installation of flashings necessary for the overall weather barrier. Concessions should have solid surface/material counter tops instead of wood to limit the potential for leaks.

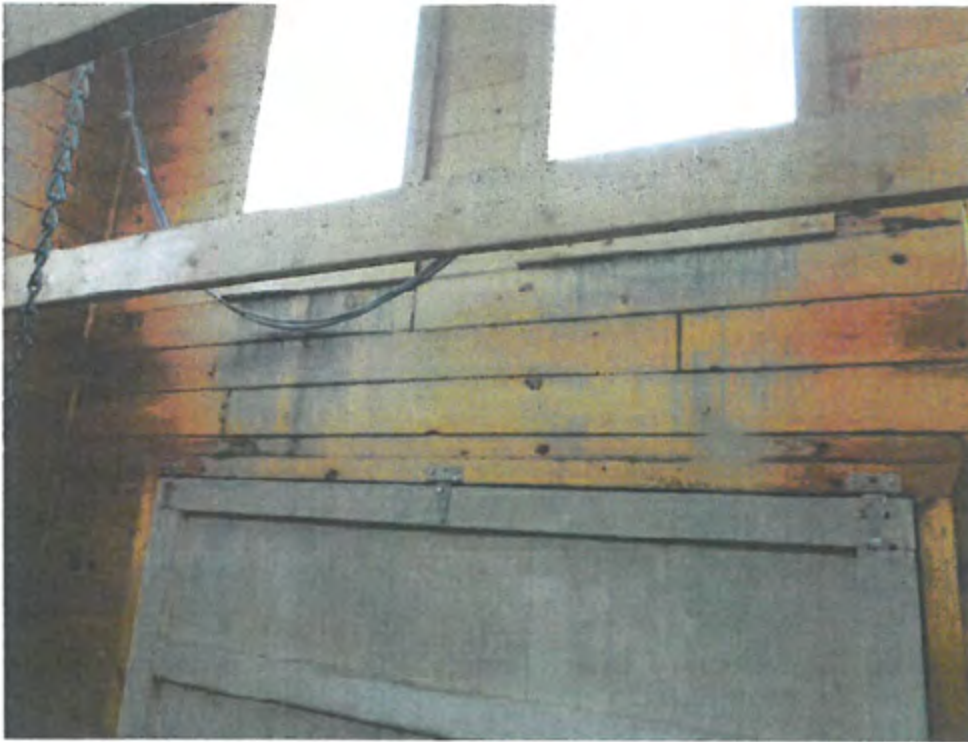
Photograph #5 – Staining below windows at south wall

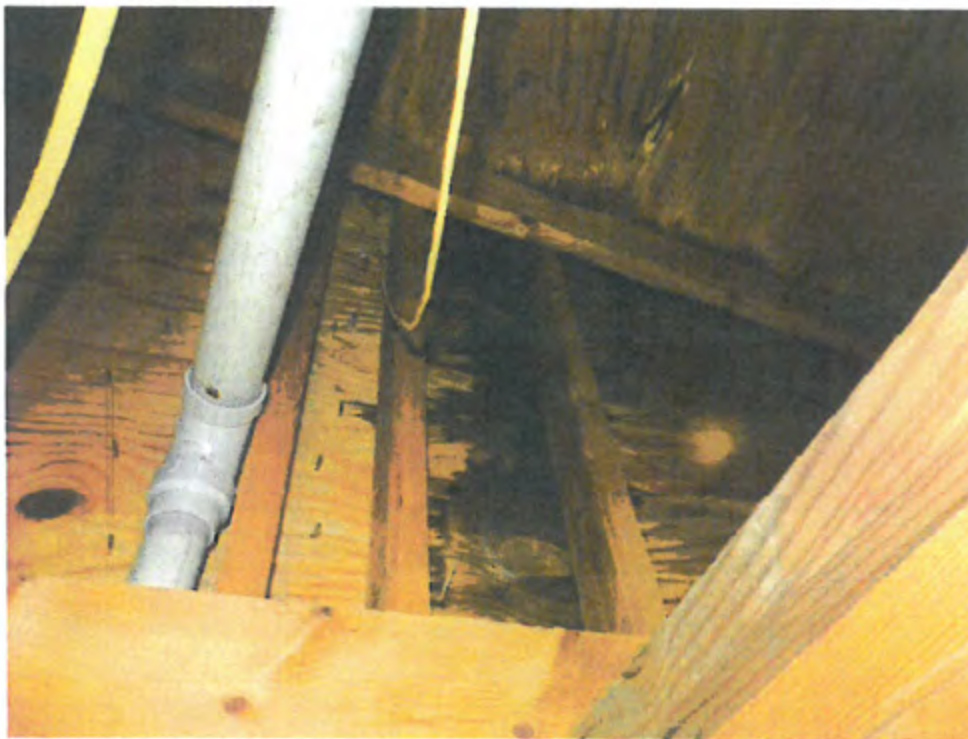
2.2.3. Roof/wall intersections where a sloped roof terminates against a vertical wall are present on most elevations. These areas do not have adequate step or diverter flashing to direct water away from the wall or prevent it from entering behind the stucco. Damaged framing was commonly observed below most of these locations (photo #6).

Photograph #6 – Staining below roof/wall intersection

2.2.4.3. Roofing will need to be partially removed to install step flashings and diverter flashings along wall intersections. The full extent of roofing removal may vary depending on underlying damage and flashing needs, though it is expected that roofing removal may be significant where full roofing replacement may be more economical.

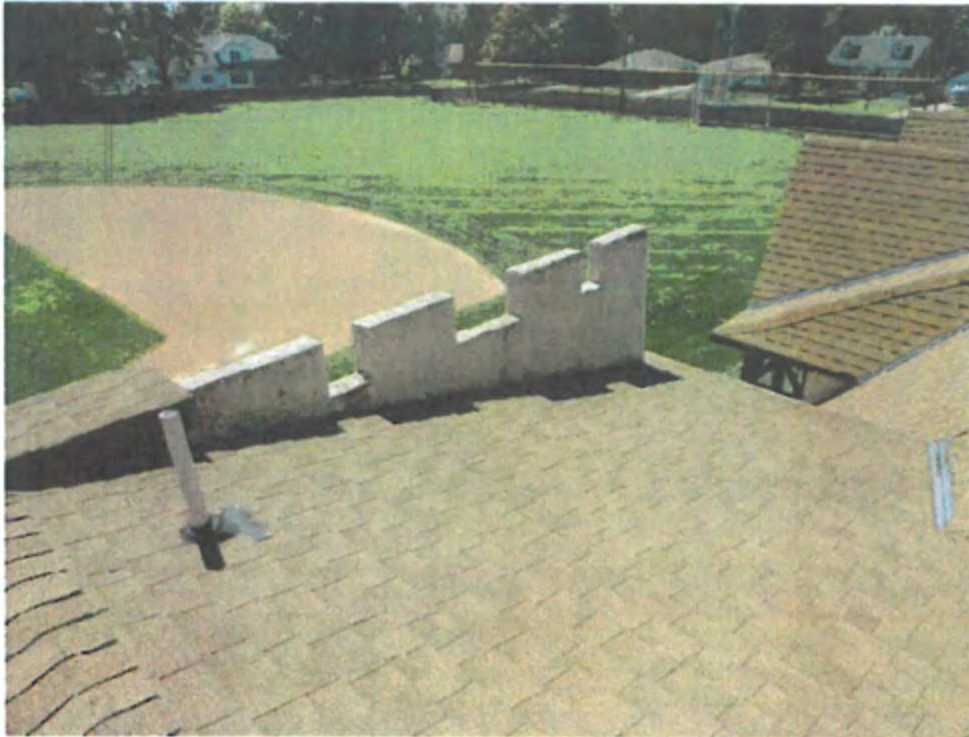
2.3.1. The parapet walls have flat top surfaces that are covered with wood and stucco. We suspect that underlying damage may exist below the caps that would not be known until the time of stucco removal (Photo #7). The use of stucco on flat surfaces is a poor construction practice and in order to ensure a water tight

Photograph #7 – Stucco parapet walls

assembly, it is recommended that the stucco and wood be omitted in favor of a roofing membrane and metal caps/coping.

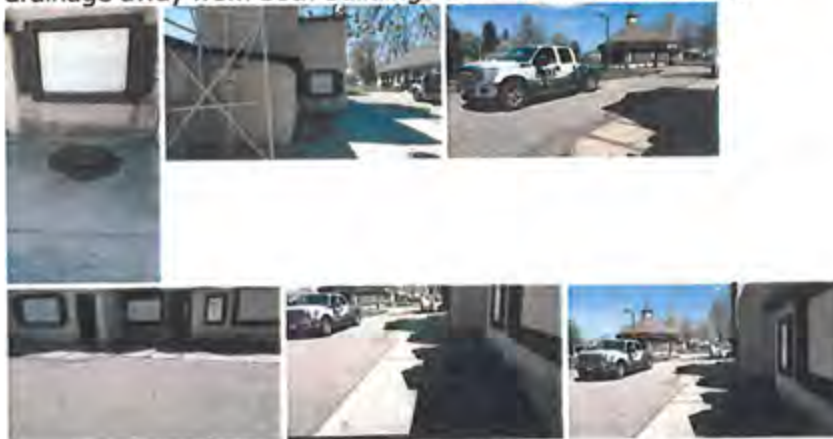
Exterior Surface Drain: Surface drain - Surface drainage is a primary problem for the lower portion of the north side of the building. Rain waters from the air and roof surfaces is a secondary contributor to rot and decay of some of the lower fascia of the building. The lot is very flat and surface waters between the building and the Pavilion to the north are routing towards the building and causing water wicking into the framing, sheathing and fascia materials. It appears the only good remedy is to tear out a large portion of pavement and concrete to re-grade the entire area between the building and pavilion and then install a semi-pervious surface with french style drainage or to add new hard surfaces to included drainage away from both buildings and into th storm sewer.

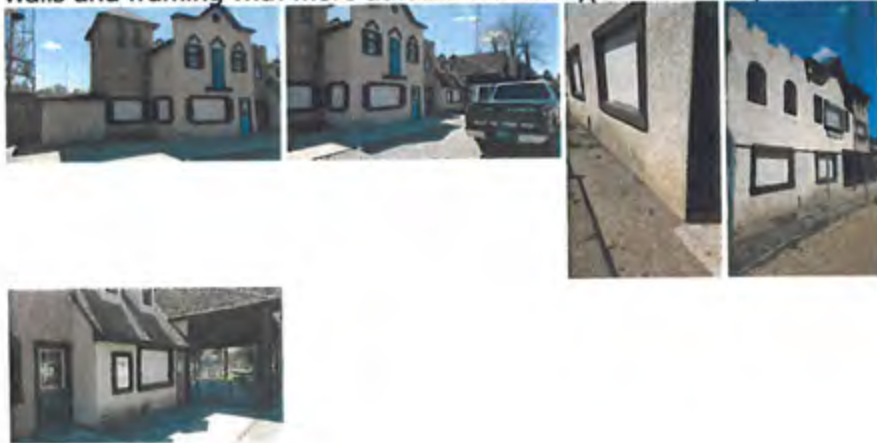
2. Visible Mold Like Substance Type: Brick, Stucco, Wood - Replace only the lower portions of north and south walls and framing with more durable cement type structural product.

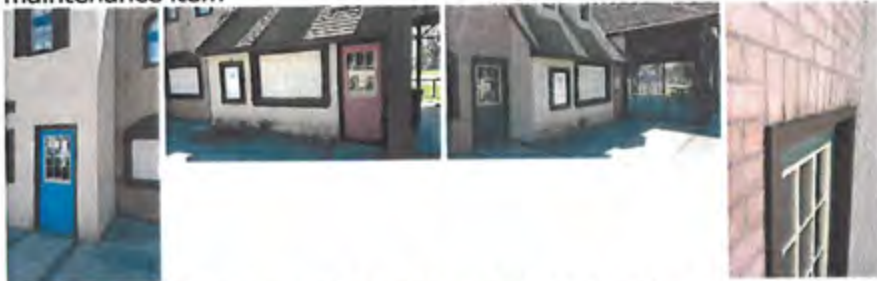
Entry Doors: Metal - All trim should be checked for caulking as an annual maintenance item

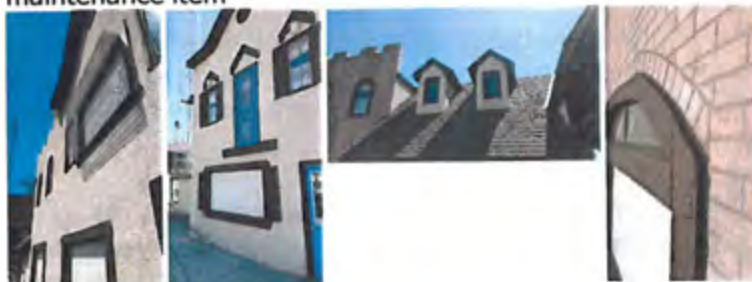
Windows: Loose caulk - All trim should be checked for caulking as an annual maintenance item

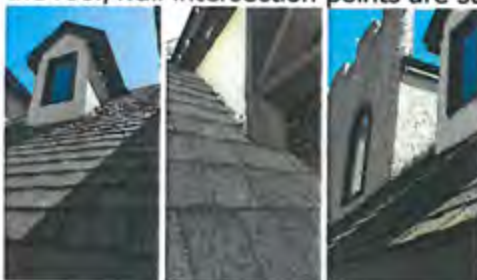
2. No Visible Suspect Mold Material: Architectural Shingle - Shingles appear to be in good condition, although the roof/wall intersection points are suspect for on-going water damage.

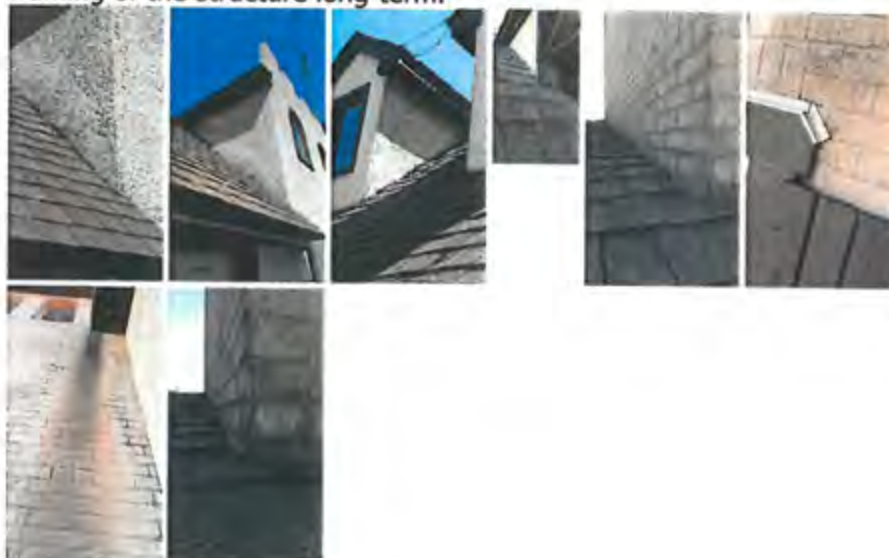
5. No Visible Suspect Mold Flashing: Unknown - hidden - Some areas of roof/wall intersections have non-existent or hidden flashing. All roof/wall intersections and caulked joints need to be evaluated for current maintenance needs and inspection by a qualified roofing company. These areas need to be kept dry to protect the sheathing and framing of the structure long-term.

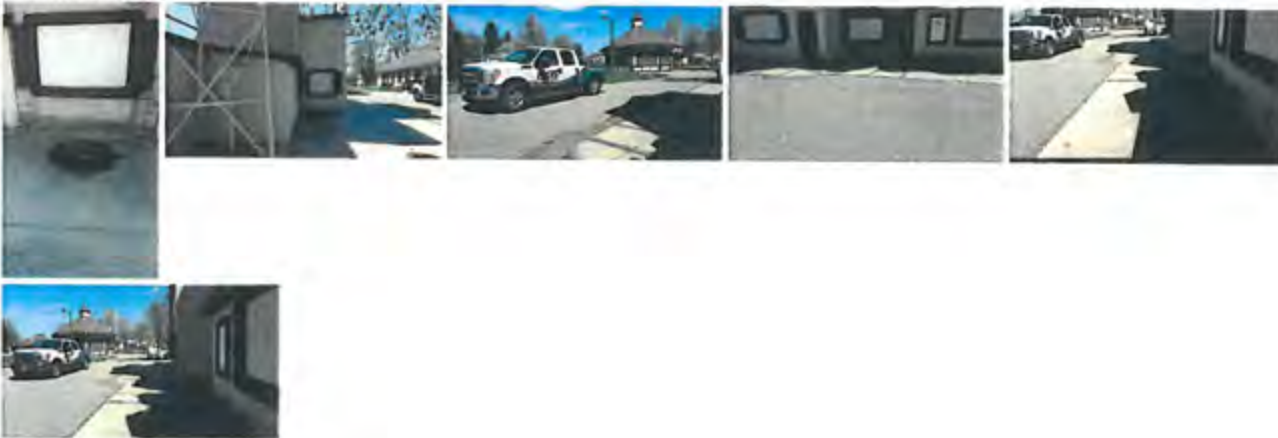
1. **Exterior Surface Drain: Surface drain** - Surface drainage is a primary problem for the lower portion of the north side of the building. Rain waters from the air and roof surfaces is a secondary contributor to rot and decay of some of the lower fascia of the building. The lot is very flat and surface waters between the building and the Pavilion to the north are routing towards the building and causing water wicking into the framing, sheathing and fascia materials. It appears the only good remedy is to tear out a large portion of pavement and concrete to re-grade the entire area between the building and pavilion and then install a semi-pervious surface with french style drainage or to add new hard surfaces to included drainage away from both buildings and into the storm sewer.

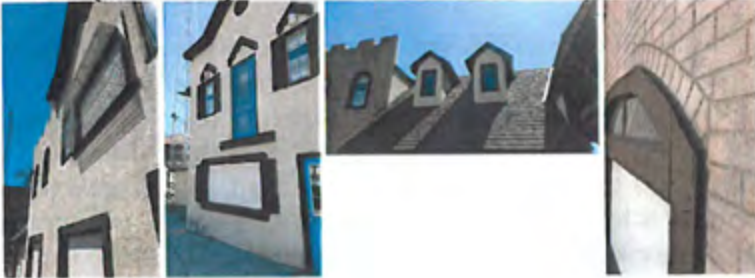
4. **Windows: Loose caulk** - All trim should be checked for caulking as an annual maintenance item

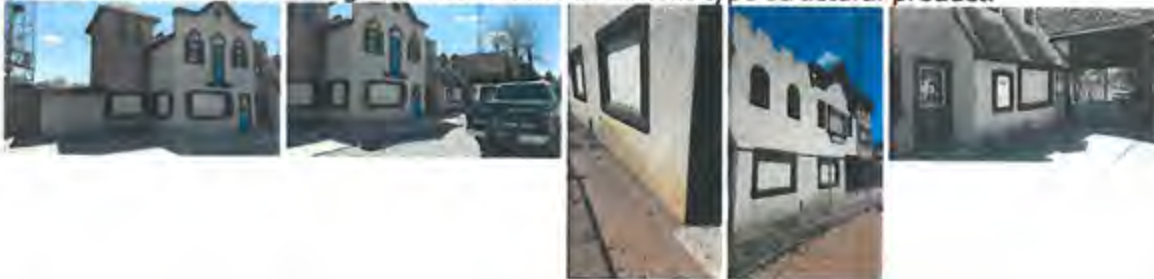
2. All sides of the building Exterior Surface Type: Brick, Stucco, Wood - Replace only the lower portions of north and south walls and framing with more durable cement type structural product.
