TO: Parks & Recreation Commission Members
FROM: Steve Helget, City Administrator
DATE: August 16, 2016
SUBJECT: Willkommen Memorial Park Old Town Buildings

The Commission met at Willkommen Memorial Park for its April 19th regular meeting and reviewed and discussed the Old Town Buildings. The Commission directed staff to solicit proposals for conducting mold mediation of the buildings. Brent Aretz, Public Works Director has solicited two proposals (see enclosures). The proposals are as follows:

Home Inspection Report

21 Main Street E
Norwood Young America, MN 55368

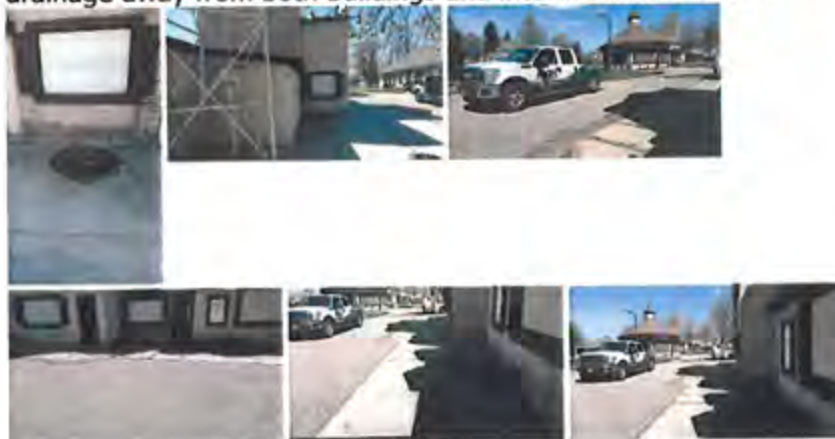
1. Conditions Favorable

Exterior Surface Drain: Surface drain - Surface drainage is a primary problem for the lower portion of the north side of the building. Rain waters from the air and roof surfaces is a secondary contributor to rot and decay of some of the lower fascia of the building. The lot is very flat and surface waters between the building and the Pavilion to the north are routing towards the building and causing water wicking into the framing, sheathing and fascia materials. It appears the only good remedy is to tear out a large portion of pavement and concrete to re-grade the entire area between the building and pavilion and then install a semi-pervious surface with french style drainage or to add new hard surfaces to included drainage away from both buildings and into th storm sewer.

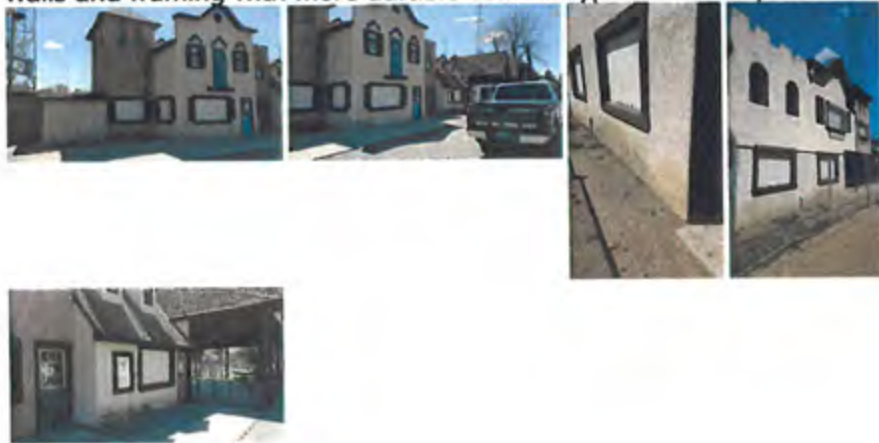
All sides of the building Exterior Surface

2. Visible Mold Like Substance Type: Brick, Stucco, Wood - Replace only the lower portions of north and south walls and framing with more durable cement type structural product.

1. Visible Mold Like Substance Exterior Foundation: Wood Framed - ProCare recommends removal of the lower stucco that is water and mold damaged to a height up to four feet tall and to replace the stucco with a brick or cement type of material that can be sealed and adequately drained, that will also repel waters that are dripped, wind driven, snow or ice accumulated, etc. Due to the fact that much of the damage is hidden in the walls, it is safe to assume that a certain portion of the framing may either need removal or remediation and shoring up.

It is further suggested that a qualified engineer/architect provide a material that can replace all lower wood framing, while maintaining the install and integrity of the existing building.

ProCare can provide demo and remediation of the mold affected areas, leaving most, or all, framing in place. A temporary cleaning of the framing can be completed to avoid cross-contaminating other interior areas and surfaces of the building.

Another contractor could then come and set up to shore up the building and replace the lower framing with a more water durable cement like product to appear as a wainscot, but which will also function as the main lower structure for the walls of the building.

The majority of the structure and face of the building are in great condition and should be preserved. The mold and rot issues at the lower walls as wells as the surface drainage issues need to be remedied, to protect public health.

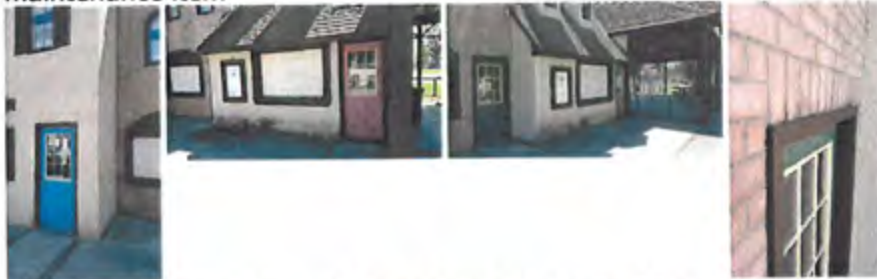
3. No Visible Suspect Mold

Entry Doors: Metal - All trim should be checked for caulking as an annual maintenance item

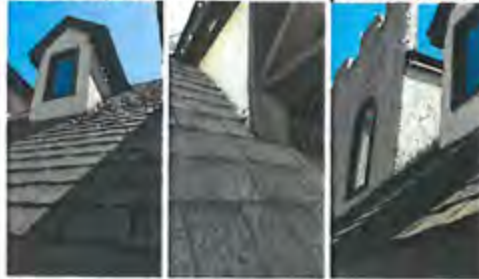
1. Method of Inspection: Ground level
2. No Visible Suspect Mold **Material: Architectural Shingle - Shingles appear to be in good condition, although the roof/wall intersection points are suspect for on-going water damage.**

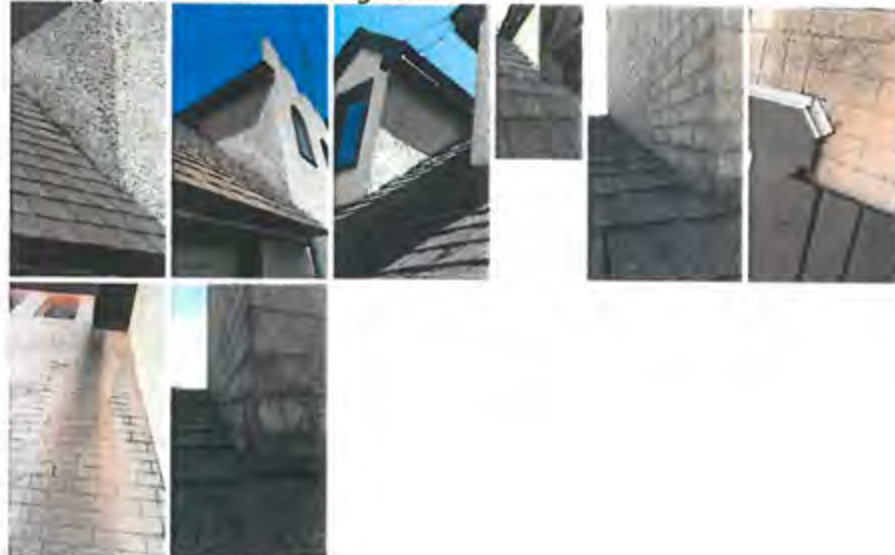
3. Type: Gable
4. Approx Age: More than 5 years old
5. No Visible Suspect Mold **Flashing: Unknown - hidden - Some areas of roof/wall intersections have non-existent or hidden flashing. All roof/wall intersections and caulked joints need to be evaluated for current maintenance needs and inspection by a qualified roofing company. These areas need to be kept dry to protect the sheathing and framing of the structure long-term.**

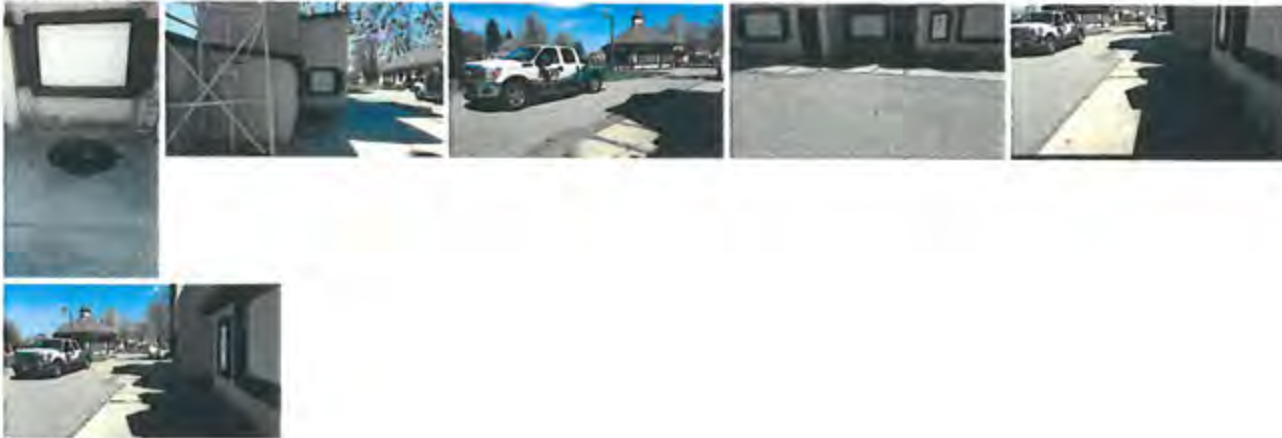
1. Exterior Surface Drain: Surface drain - Surface drainage is a primary problem for the lower portion of the north side of the building. Rain waters from the air and roof surfaces is a secondary contributor to rot and decay of some of the lower fascia of the building. The lot is very flat and surface waters between the building and the Pavilion to the north are routing towards the building and causing water wicking into the framing, sheathing and fascia materials. It appears the only good remedy is to tear out a large portion of pavement and concrete to re-grade the entire area between the building and pavilion and then install a semi-pervious surface with french style drainage or to add new hard surfaces to included drainage away from both buildings and into th storm sewer.

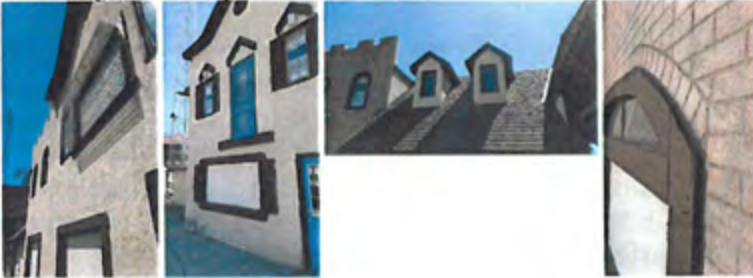
4. Windows: Loose caulk - All trim should be checked for caulking as an annual maintenance item

Windows: (continued)

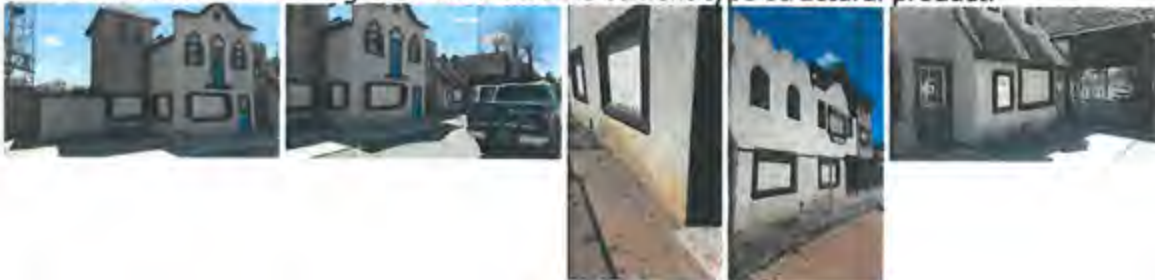
2. All sides of the building Exterior Surface Type: Brick, Stucco, Wood - Replace only the lower portions of north and south walls and framing with more durable cement type structural product.

1. Exterior Foundation: Wood Framed - ProCare recommends removal of the lower stucco that is water and mold damaged to a height up to four feet tall and to replace the stucco with a brick or cement type of material that can be sealed and adequately drained, that will also repel waters that are dripped, wind driven, snow or ice accumulated, etc. Due to the fact that much of the damage is hidden in the walls, it is safe to assume that a certain portion of the framing may either need removal or remediation and shoring up.

It is further suggested that a qualified engineer/architect provide a material that can replace all lower wood framing, while maintaining the install and integrity of the existing building.

ProCare can provide demo and remediation of the mold affected areas, leaving most, or all, framing in place. A temporary cleaning of the framing can be completed to avoid cross-contaminating other interior areas and surfaces of the building.

Another contractor could then come and set up to shore up the building and replace the lower framing with a more water durable cement like product to appear as a wainscot, but which will also function as the main lower structure for the walls of the building.

The majority of the structure and face of the building are in great condition and should be preserved. The mold and rot issues at the lower walls as wells as the surface drainage issues need to be remedied, to protect public health.
